NE 94th Avenue

NE Padden Parkway - NE 99th Street

Clark County

Project Description

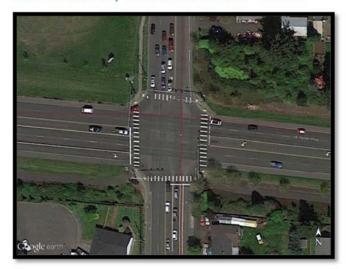
NE 94th Avenue / Padden Intersection - Before

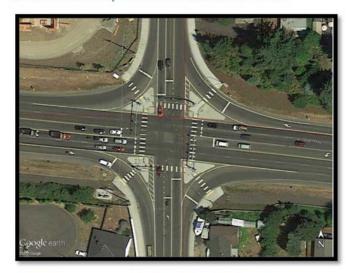
NE 94th Avenue / Padden Intersection – After

Install upgrades at the intersection of NE 94th Avenue / Padden Parkway: additional left turn lanes, new right turn lanes, acceleration lanes, pedestrian islands, added and improved bicycle lanes, lighting upgrades, a new LED traffic signal with data collection and traffic surveillance equipment.
